**DRAFT FINAL REPORT
SP-G1**

**EFFECTS OF PROJECT OPERATIONS ON
GEOMORPHIC PROCESSES UPSTREAM OF
OROVILLE DAM**

**Oroville Facilities Relicensing
FERC Project No. 2100**

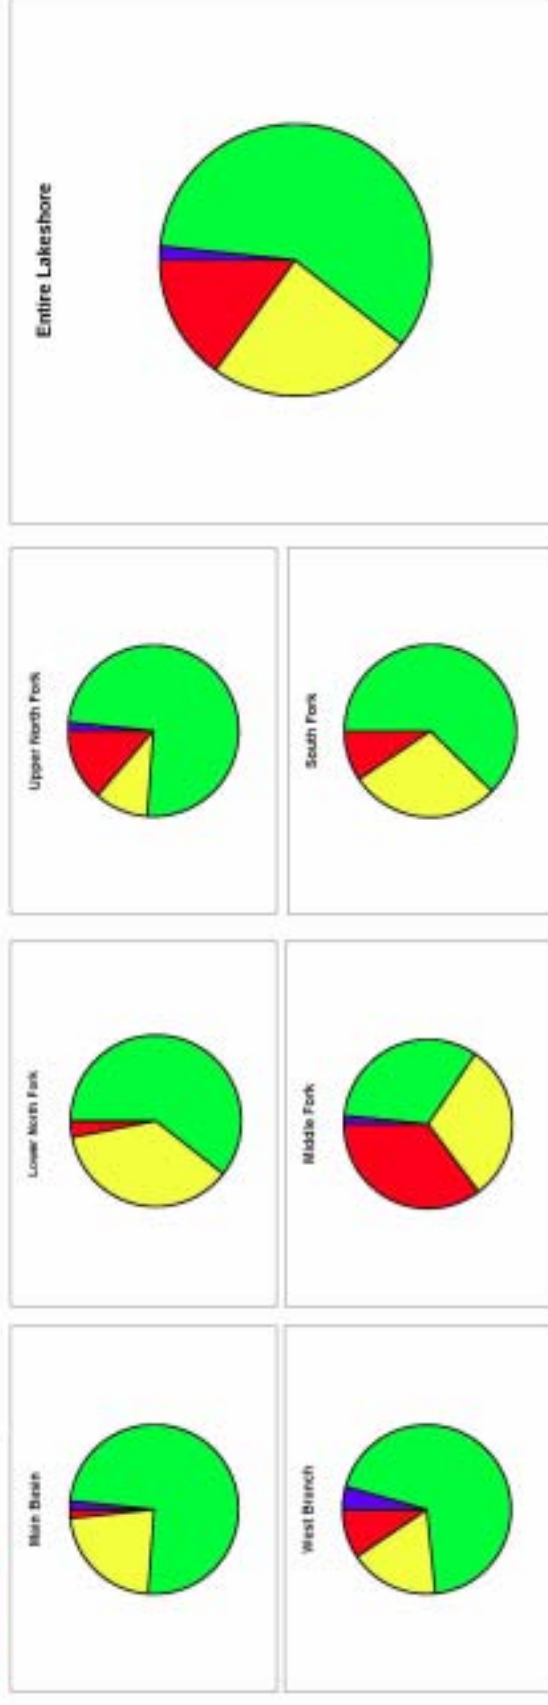
Table 6.4-1. Bank Erosion Levels and Total Volumes of Eroded Material.

Table 6.4-1 contains the total shoreline footage for the four Bank Erosion Levels for the separate branches of the lake and the main basin. Total volumes of sediment derived from the four Shoreline Bank Erosion Levels are also shown in Table 6.4-1. A total of about 15,200 acre-feet of sediment is estimated to be derived from shoreline erosion. This estimate assumes that the vertical depth of erosion observed at the shoreline continues down-slope at the same observed depth to the bottom of the Fluctuation Zone.
